Use Attainability Analysis

WBID 2817 Pike Slough

Missouri Department of Natural Resources Staff

**Field Data Sheets for Recreational Use Stream Surveys**

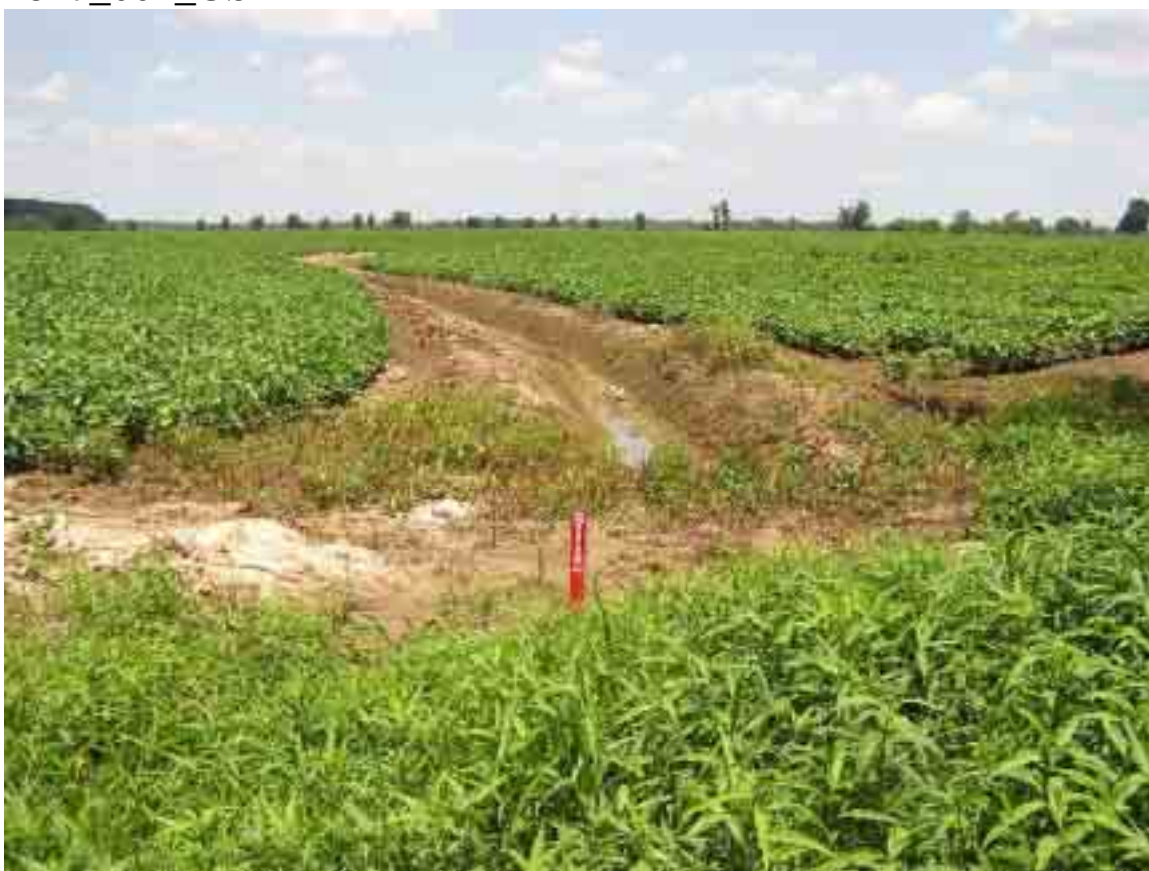
2817\_001\_US

Rifle	Width (ft):	00000	Length (ft):	00000	Avg. Depth (ft):	00000	Max. Depth (ft):	00000
Run	Width (ft):	00000	Length (ft):	00000	Avg. Depth (ft):	00000	Max. Depth (ft):	00000
Pool	Width (ft):	00000	Length (ft):	00000	Avg. Depth (ft):	00000	Max. Depth (ft):	00000
Flow	Present?	Yes	No	Estimated (ft <sup>3</sup> /sec): 00000

00000% Cobble	00000% Gravel	00000% Sand	00000% Silt	100	00000% Mud/Clay	00000% Bedrock
---------------	---------------	-------------	-------------	-----	-----------------	----------------

00000	None - upstream	Weeds - downstream
-------	-----------------	--------------------

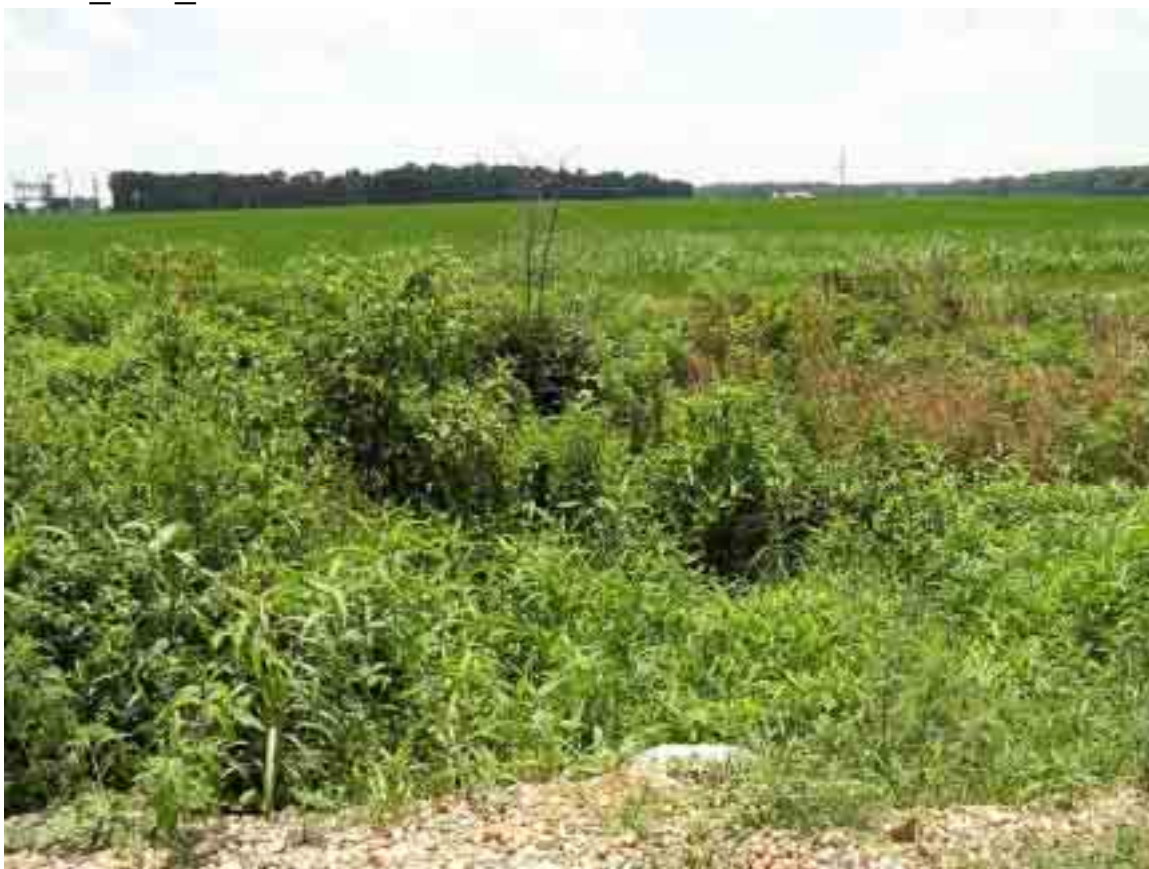
2817\_001\_DS

Rifle	Width (ft):	00000	Length (ft):	00000	Avg. Depth (ft):	00000	Max. Depth (ft):	00000
Run	Width (ft):	00000	Length (ft):	00000	Avg. Depth (ft):	00000	Max. Depth (ft):	00000
Pool	Width (ft):	00000	Length (ft):	00000	Avg. Depth (ft):	00000	Max. Depth (ft):	00000
Flow	Present?	Yes	No	Estimated (ft <sup>3</sup> /sec): 00000

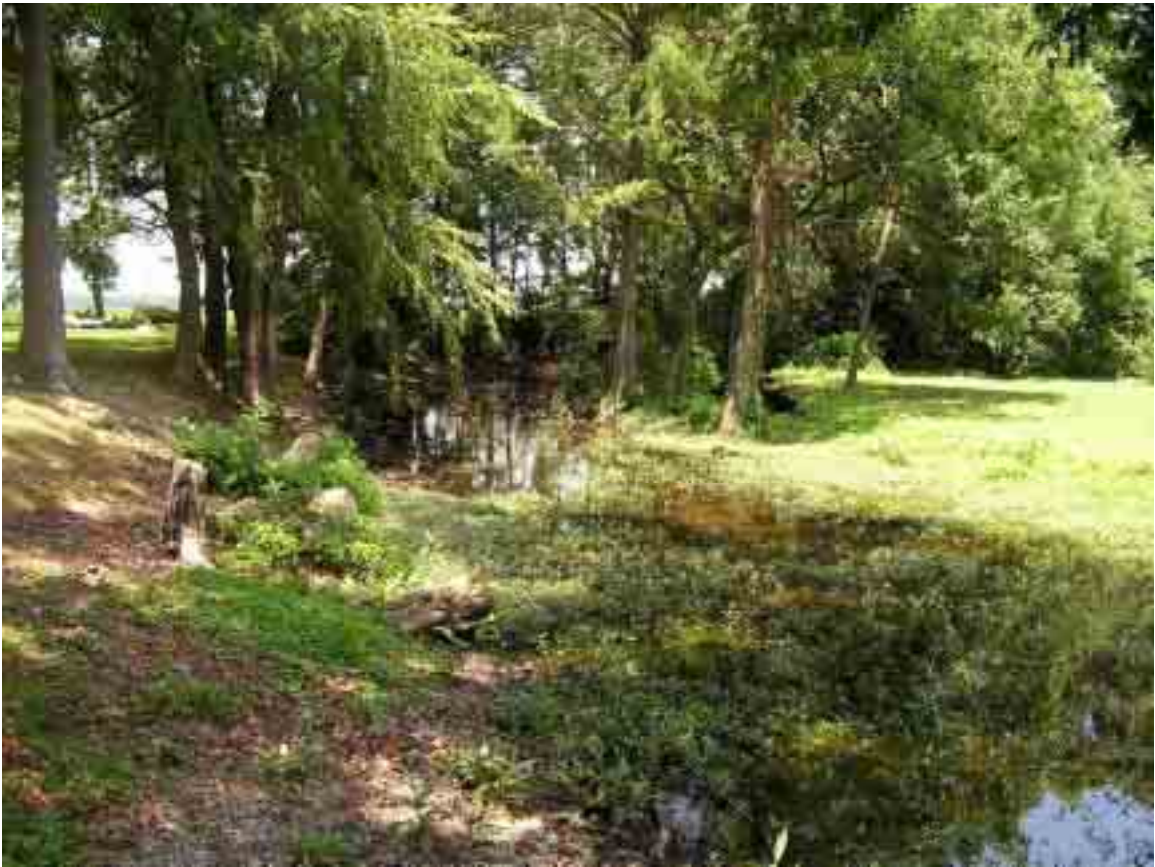
2817\_002\_US

Riffle	Width (ft): 00000	Length (ft): 00000	Avg. Depth (ft): 00000	Max. Depth (ft): 00000
Run	Width (ft): 00000	Length (ft): 00000	Avg. Depth (ft): 00000	Max. Depth (ft): 00000
Pool	Width (ft): 00000.33	Length (ft): 00000	Avg. Depth (ft): 00000.5	Max. Depth (ft): 00000.5
Flow	Present? <input checked="" type="radio"/> Yes <input type="radio"/> No	Standing Water		Estimated (ft <sup>3</sup> /sec): 00000

00000% Cobble	00000% Gravel	00000% Sand	00000% Silt	100	00000% Mud/Clay	00000% Bedrock
---------------	---------------	-------------	-------------	-----	-----------------	----------------

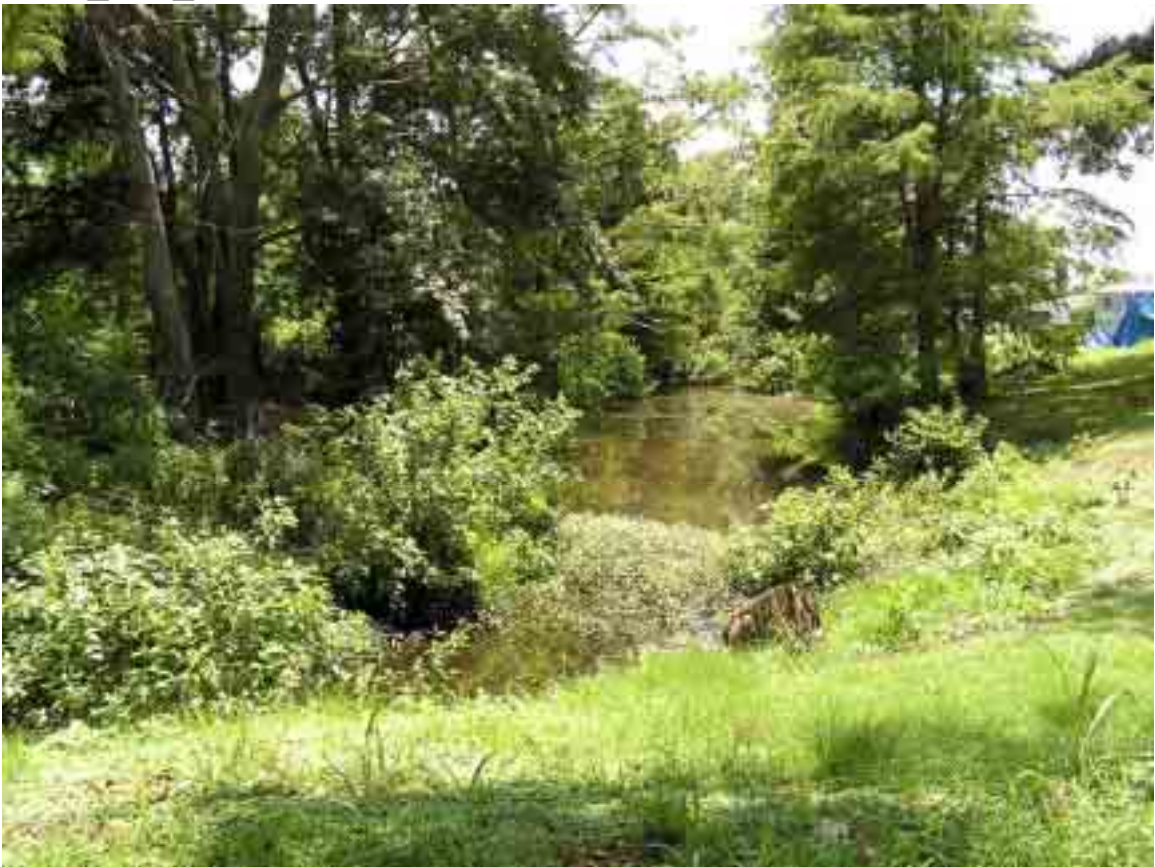
2817\_002\_DS

Riffle	Width (ft): 00000	Length (ft): 00000	Avg. Depth (ft): 00000	Max. Depth (ft): 00000
Run	Width (ft): 00000	Length (ft): 00000	Avg. Depth (ft): 00000	Max. Depth (ft): 00000
Pool	Width (ft): 00000.33	Length (ft): 00000	Avg. Depth (ft): 00000.5	Max. Depth (ft): 00000.5
Flow	Present? <input checked="" type="radio"/> Yes <input type="radio"/> No	Standing Water		Estimated (ft <sup>3</sup> /sec): 00000

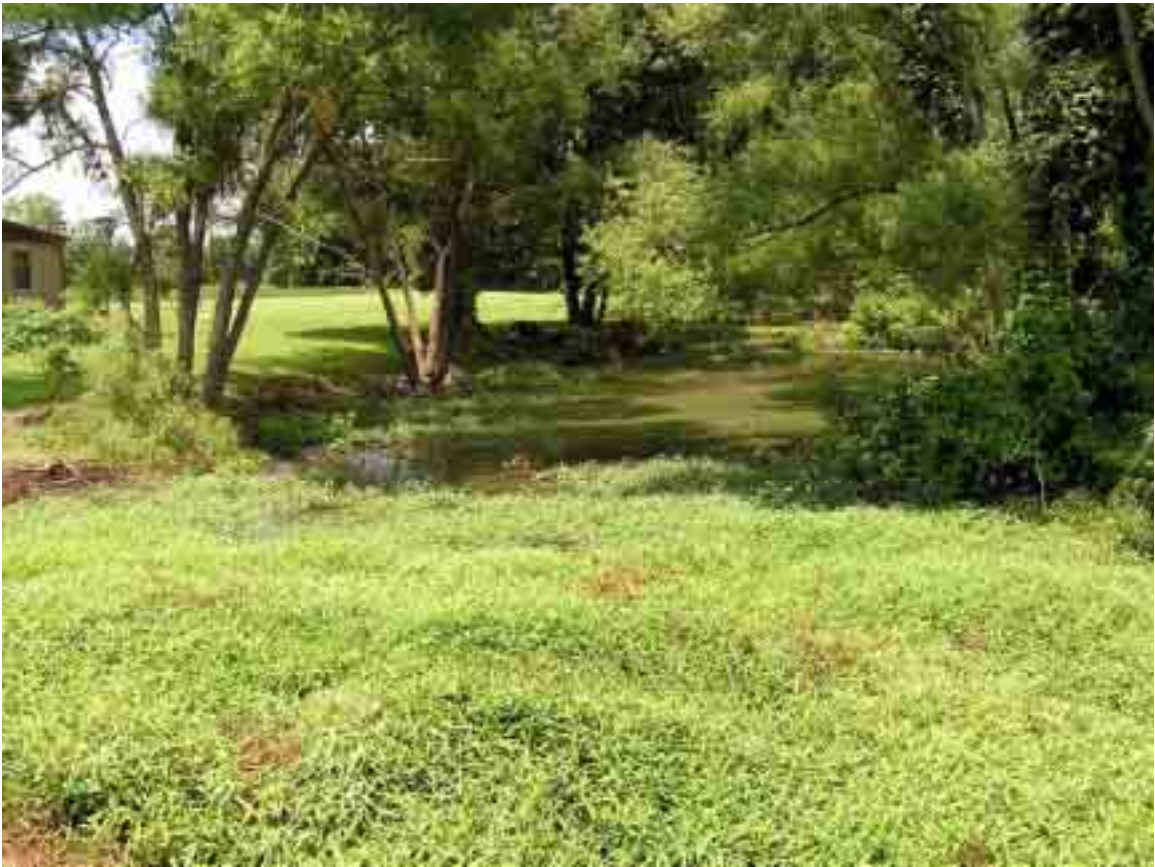
2817\_003\_US

Riffle	Width (ft): 00000	Length (ft): 00000	Avg. Depth (ft): 00000	Max. Depth (ft): 00000
Run	Width (ft): 00000	Length (ft): 00000	Avg. Depth (ft): 00000	Max. Depth (ft): 00000
Pool	Width (ft): 0000030	Length (ft): 0000060	Avg. Depth (ft): 00000.5	Max. Depth (ft): 00000 1 ft
Flow	Present? Yes <input checked="" type="radio"/> No <input checked="" type="radio"/>	Standing Water	Estimated (ft <sup>3</sup> /sec): 00000

00000% Cobble	00000% Gravel	00000% Sand	00000% Silt	100	00000% Bedrock	00000% Mud/Clay
---------------	---------------	-------------	-------------	-----	----------------	-----------------

00000	Algal growth on surface
-------	-------------------------

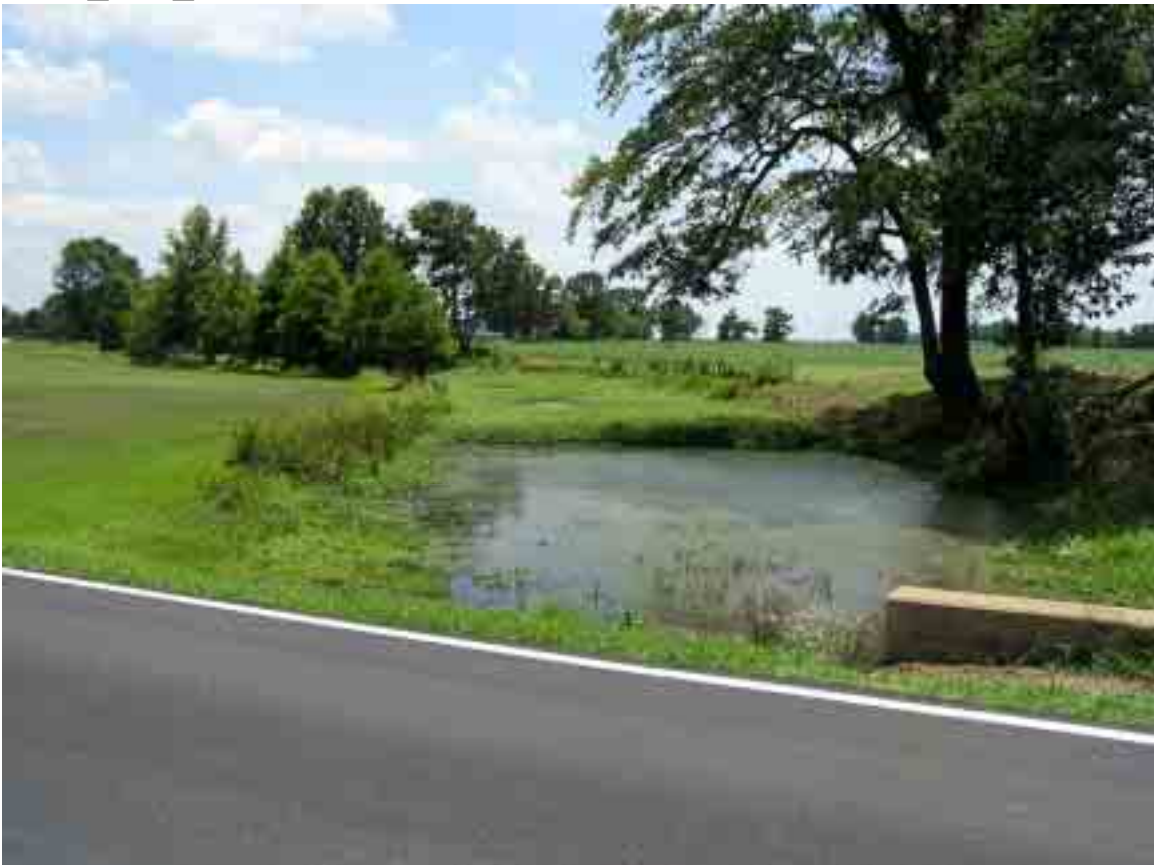
2817\_003\_DS

Riffle	Width (ft): 00000	Length (ft): 00000	Avg. Depth (ft): 00000	Max. Depth (ft): 00000
Run	Width (ft): 00000	Length (ft): 00000	Avg. Depth (ft): 00000	Max. Depth (ft): 00000
Pool	Width (ft): 0000030	Length (ft): 0000050	Avg. Depth (ft): 00000.5	Max. Depth (ft): 00000 1 ft
Flow	Present? Yes <input checked="" type="radio"/> No <input checked="" type="radio"/>	Standing Water	Estimated (ft <sup>3</sup> /sec): 00000

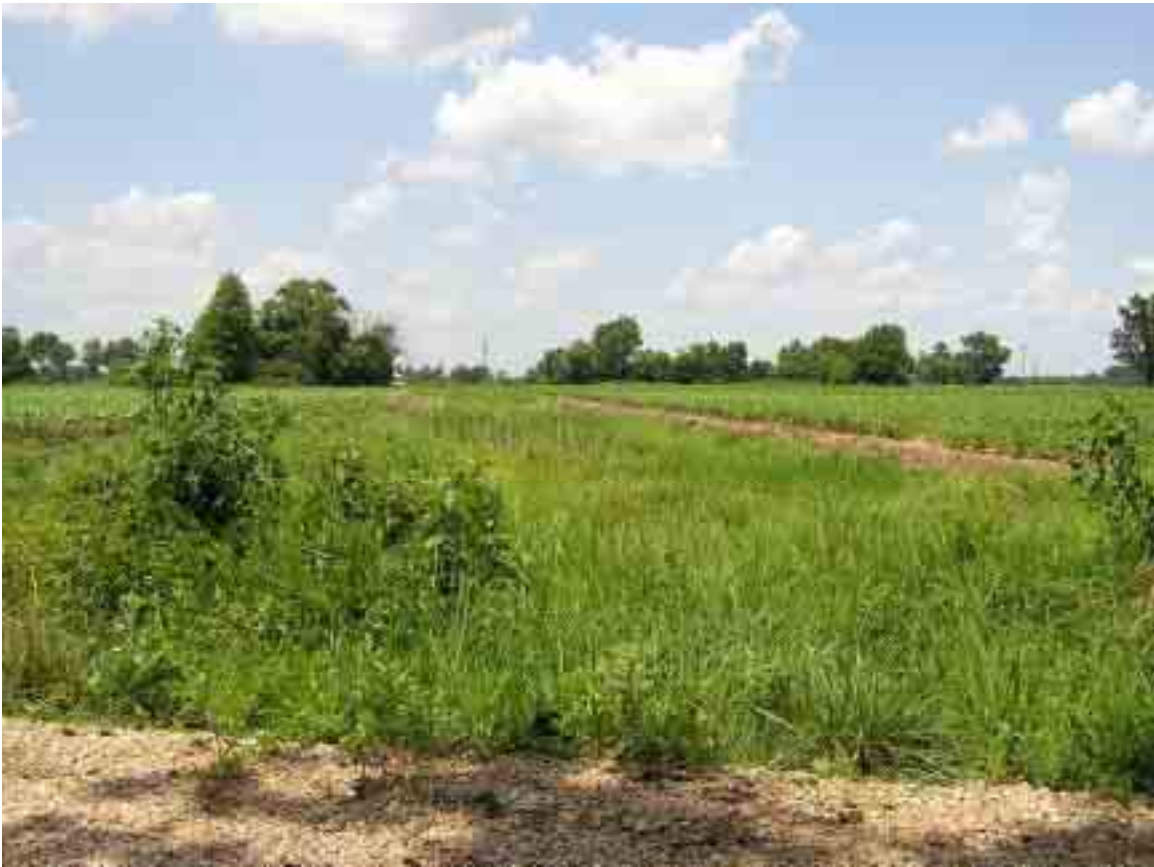
2817\_004\_US

No Water in Ditch
